Release Notes for the Cisco 831, 836 and 837 Routers and SOHO 91, 96 and 97 Routers

This document describes new and changed information for the following documents:

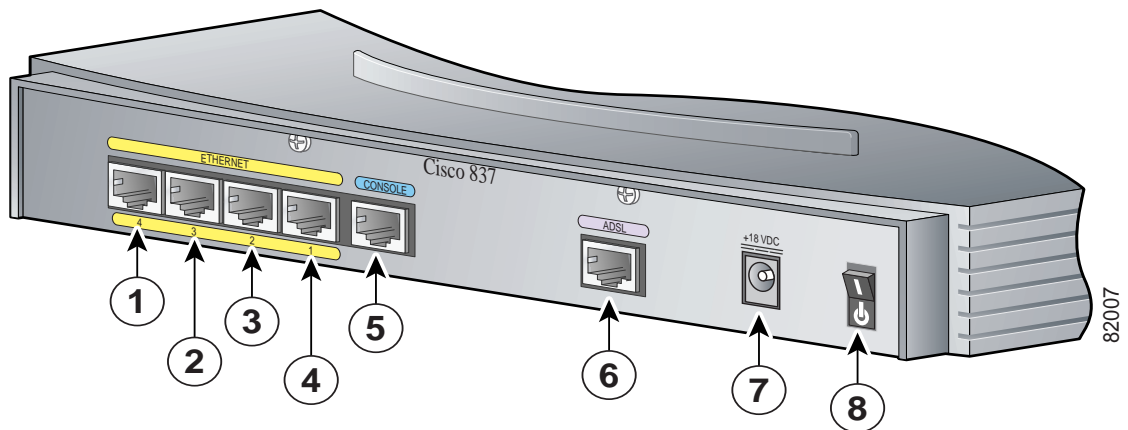
Figure 1 Back Panel of the Cisco 837 Router

The switch cover wording on the back panel of the Cisco 831, 836 and 837 routers, and the Cisco SOHO 91, 96 and 97 routers is not correct. The words “ON” and “OFF” shown on the switch cover should be “1” and “0” as depicted in the following figures. “1” represents power on, while “0” represents power off. The back panel of the Cisco 831, 836 and 837 routers is almost identical to the back panel of the Cisco SOHO 91, 96 and 97 routers. The change to the switch cover will not affect any functionality of the router.

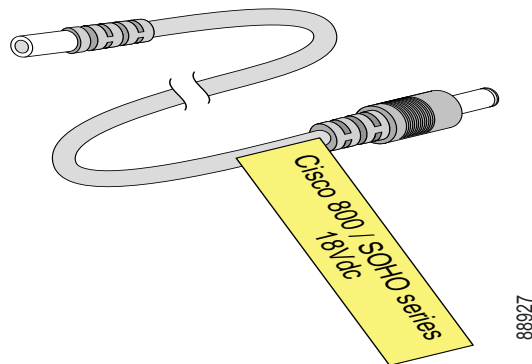
Figure 4 Input Voltage Information on Power Cord of Desktop Power Adapter

A new yellow tag will be attached to the power cord of the desktop power adapter. This tag contains the correct input voltage information to help avoid using the wrong power supply cable when connecting to the Cisco 831, 836 and 837 routers and Cisco SOHO 91, 96 and 97 routers. Always use the desktop power adapter shipped with your router to connect to the router. Refer to Figure 4 for detail of the yellow tag on the power cord.
