Release Notes for the Catalyst 2955, Catalyst 2950, and Catalyst 2940 Switches, Cisco IOS Release 12.1(22)EA8

May 18, 2006

Cisco IOS Release 12.1(22)EA8 runs on Catalyst 2955, Catalyst 2950, and Catalyst 2940 switches.

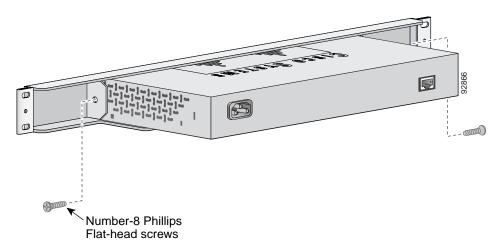
Step 1 Position the switch in the center of the mounting bracket.
